**Intergovernmental Oceanographic Commission**  
Workshop Report No. 96 - Supplement 1

**IOC-UNEP-WMO-SAREC  
Planning Workshop on An Integrated  
Approach to Coastal Erosion, Sea  
Level Changes and Their Impacts**

Institute of Marine Sciences (University of Dar es Salaam)  
Zanzibar, United Republic of Tanzania, 17-21 January 1994

**Submitted Papers**

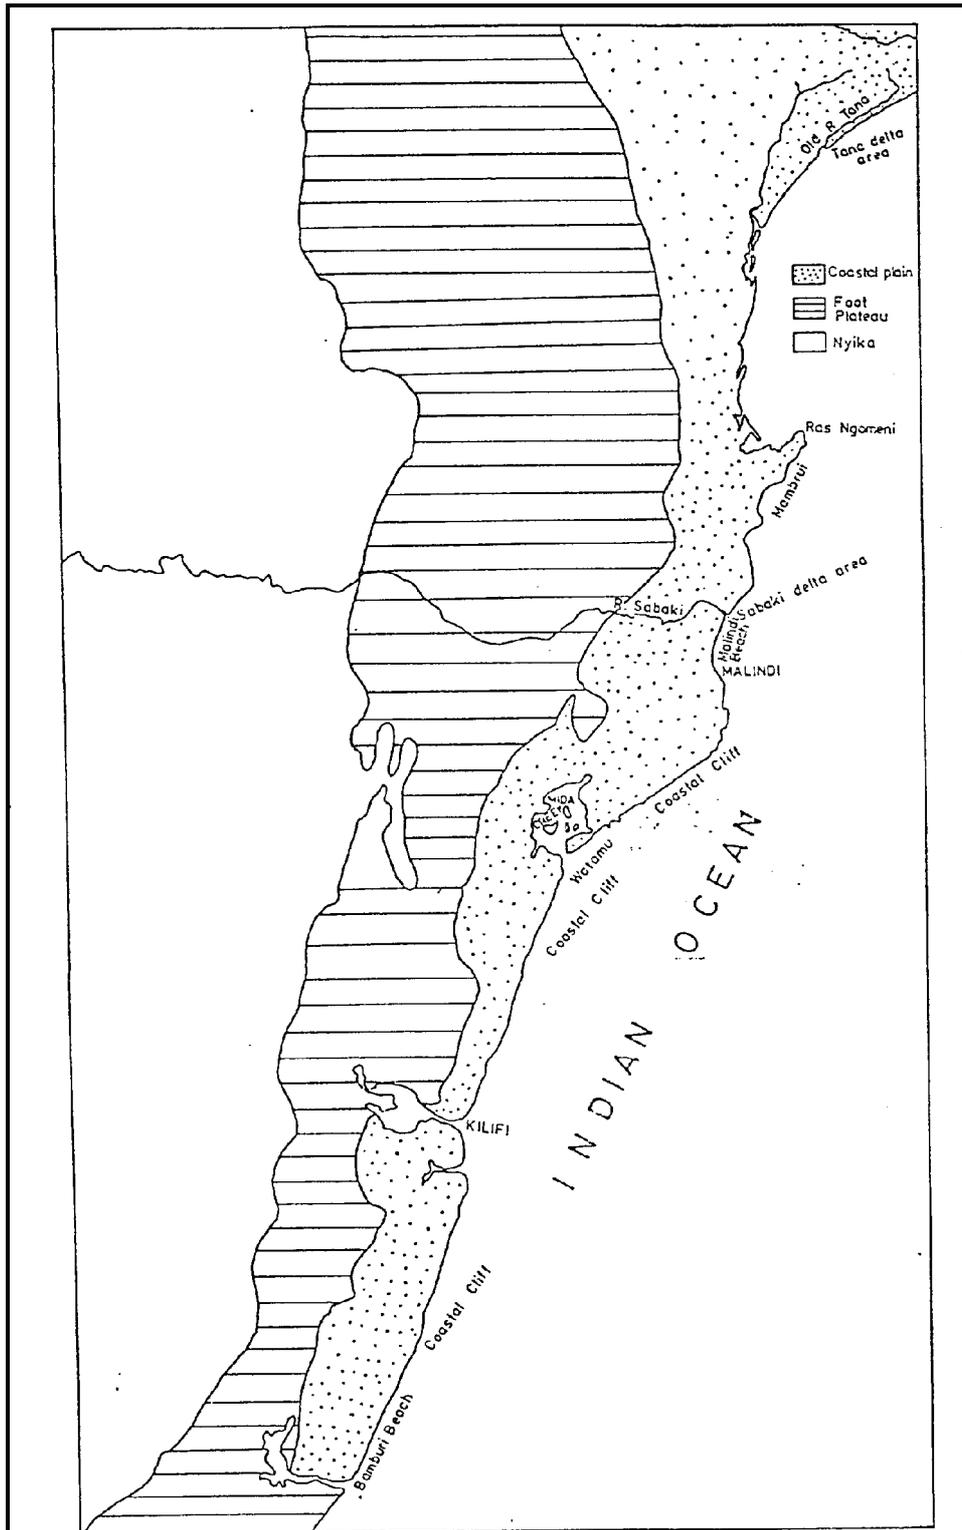
Fig: 1. Major Coastal Physiographic Provinces.

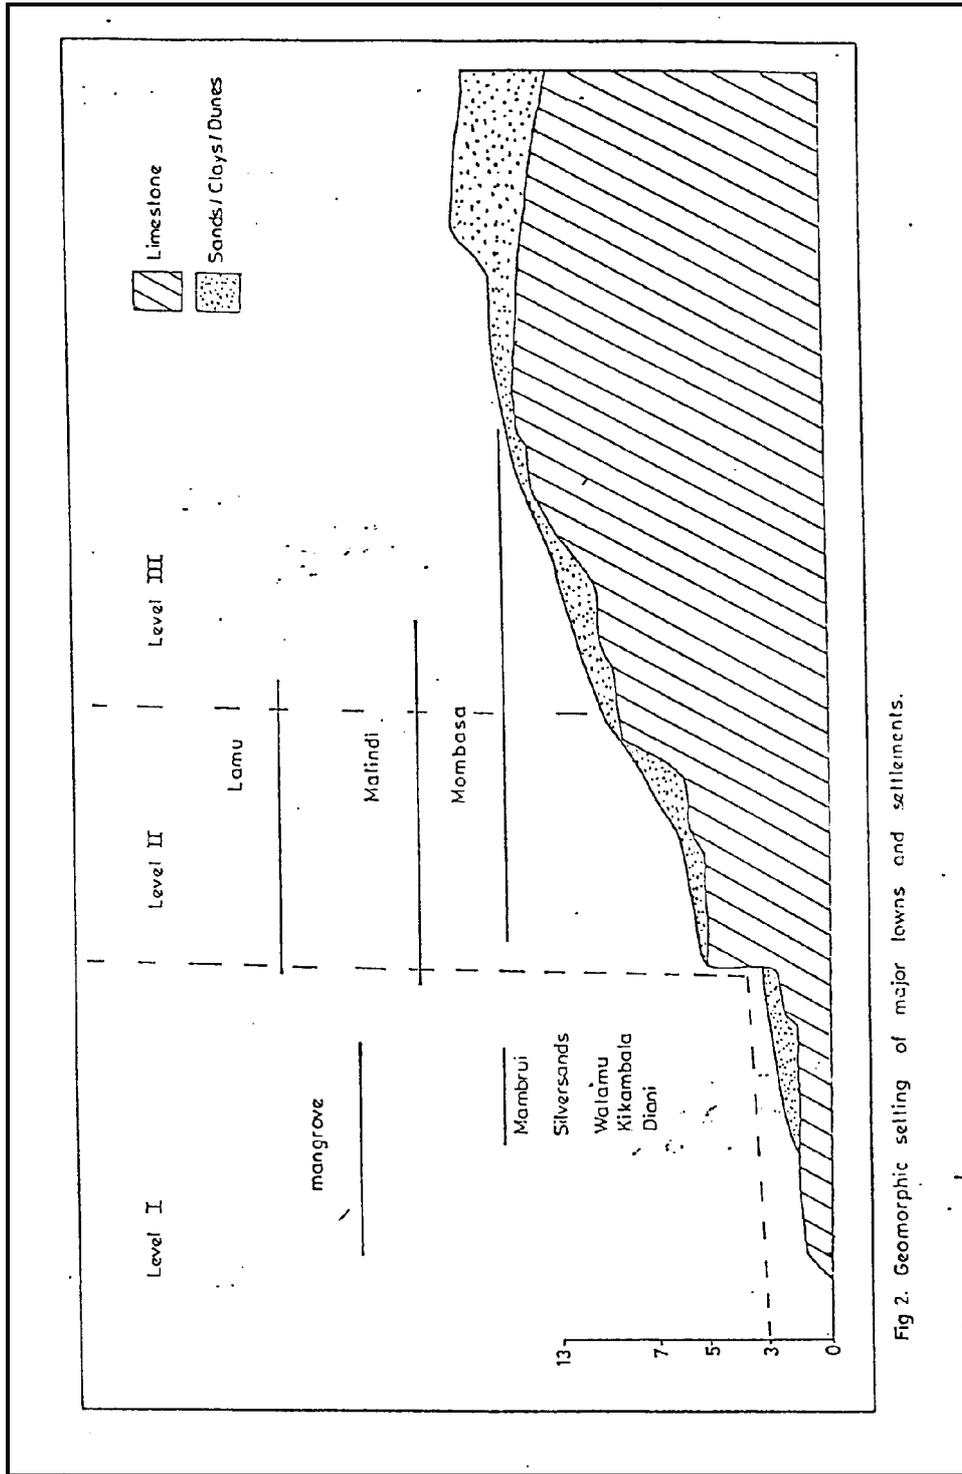
Fig 2. Geomorphic setting of major towns and settlements.

In the last three decades, Kenya coastal zone development has transformed from trade, to service oriented industry for the tourism industry. This new industry requires beautiful low lying coastal environments comprising of unconsolidated sand deposits (the beaches) (fig.2). Unlike the old sites, these

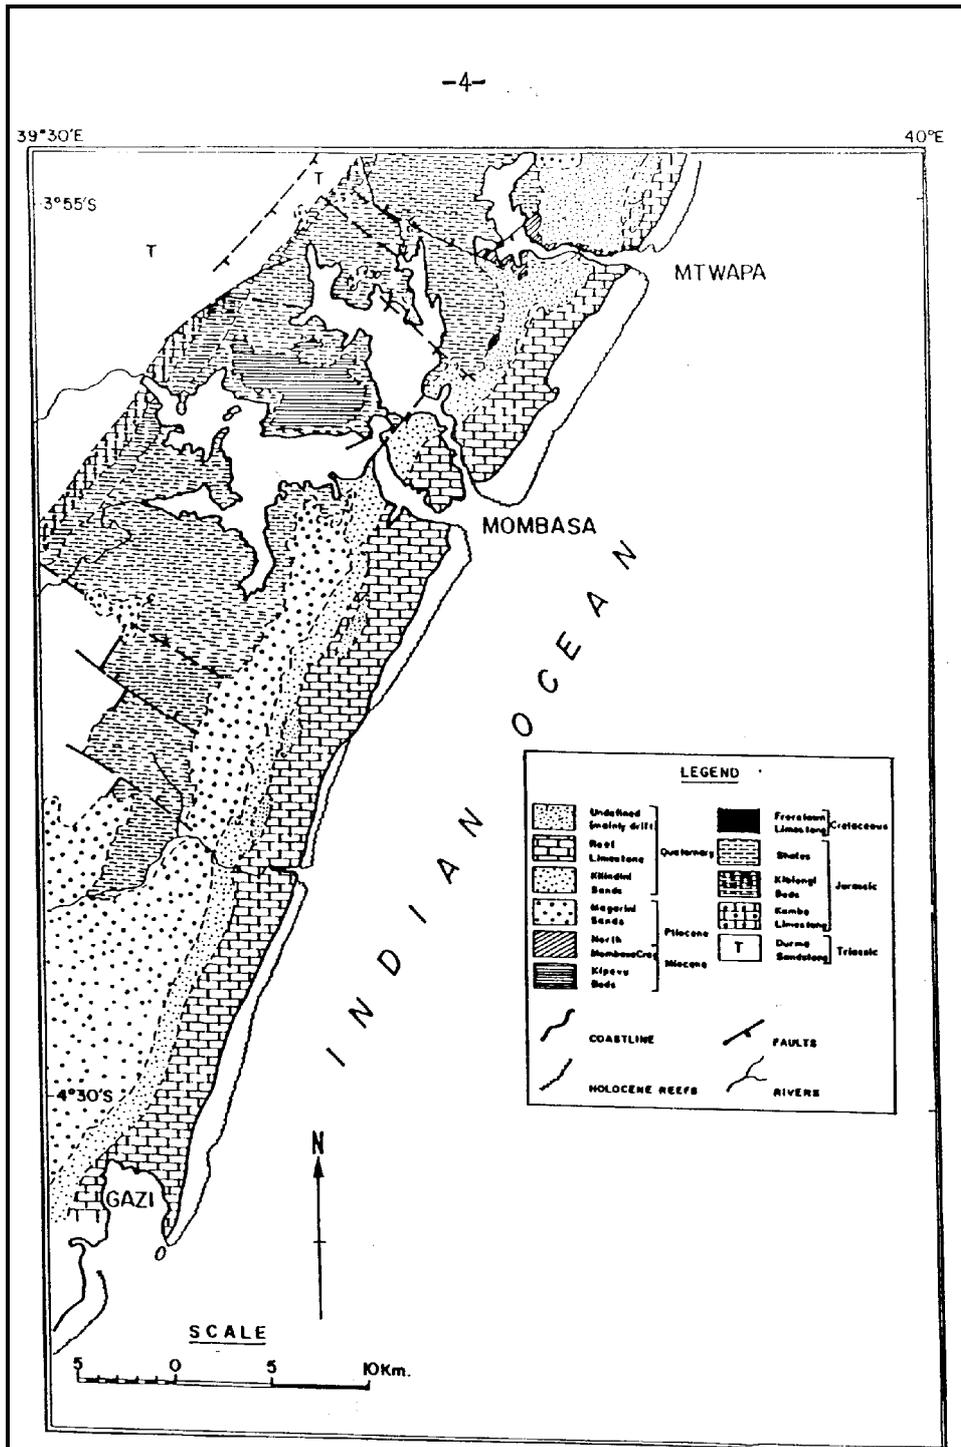
Fig. 3 shows geological map of the study area (Re-drawn from Andrew, 1981).

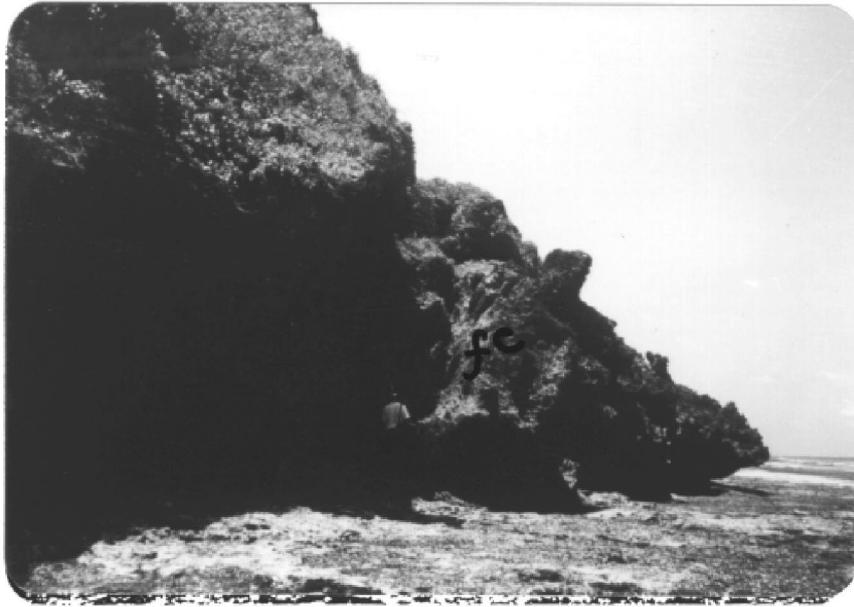
Plate 1 shows fallen cliff (fc) due to wave erosion at Mtwapa (September, 1990; Photo by P. Abuodha).

Cliffed coasts were observed at Kanamai, Shanzu, Iwetine, Nyali, Likoni [Fig.4] and at Black Cliff Point as well as Tiwi (Fig.5). The height of these cliffs ( Plate 1) was estimated to be 10 -15 m above sea level. (Abuodha, 1992). The cliffs are near vertical with pronounced wave cut notches at 4 m above sea level (Ase, 1978). Where the forces produced by the action of waves and the compression of trapped air puncture the roof of an overhanging cliff, water and spray are driven up through blow outs observed at Kanamai (Plate 2).

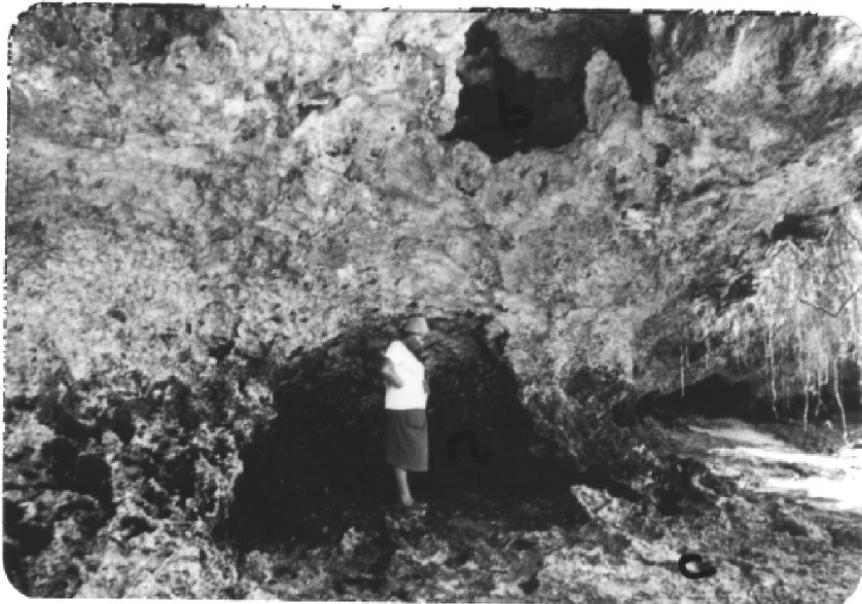
Plate 2 shows a notch (n), a blow out (b) and rugged bottom cavities (c) (September, 1990; Photo by J. Abuodha).

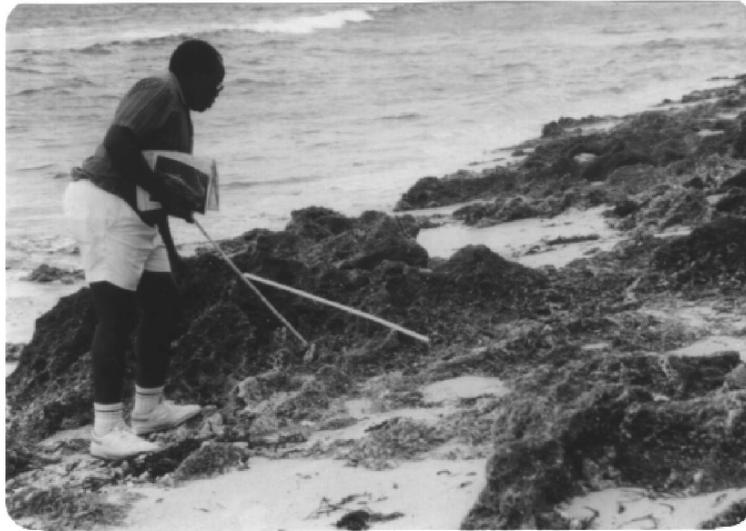
Plate 3 shows a rocky shore platform (r) marking the lower edge of the beach at Shanzu (June, 1991; Photo by S. Langat).

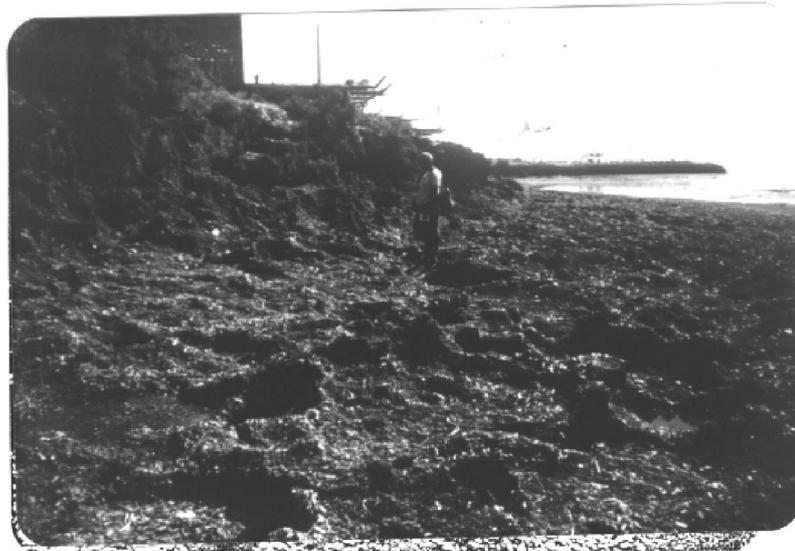
Plate 4 shows jagged surface of the rocky shore (r) at Iwetine (September, 1990; Photo by J. Abuodha).

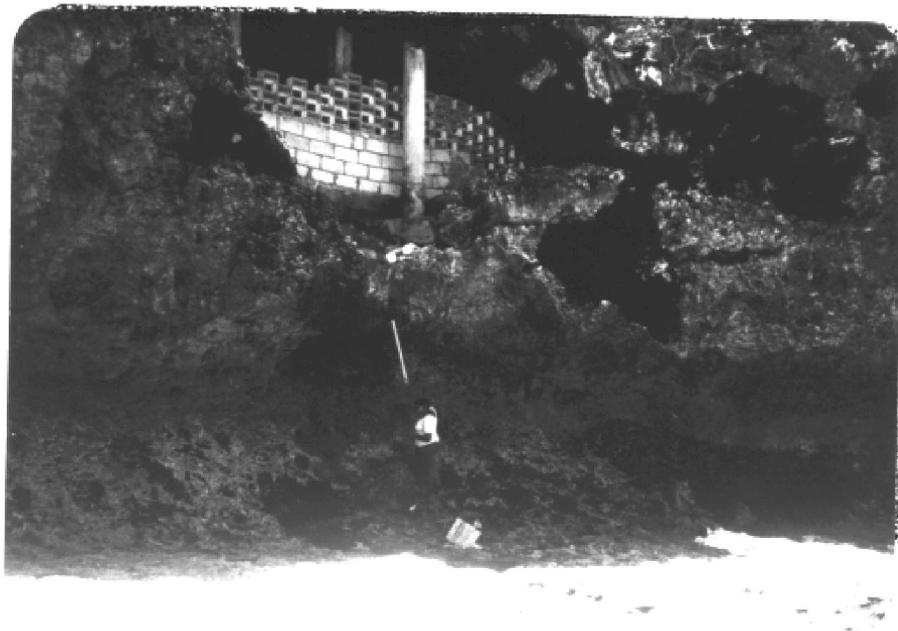
Plate .5 shows reinforcement of a hanging cliff (c) at Nyali. (September, 1990; Photo by J. Abuodha).

Human interferences are having major impacts on the coastal zone and therefore there is increasing acceptance of the need to protect the marine environment and its resources. Coastal erosion is a prevalent phenomenon along the Mombasa - Diani area. In many places, the rate of coastline retreat and the resulting environmental degradation and economic loss is on such a scale as to be alarming (Plate 5, and 6).

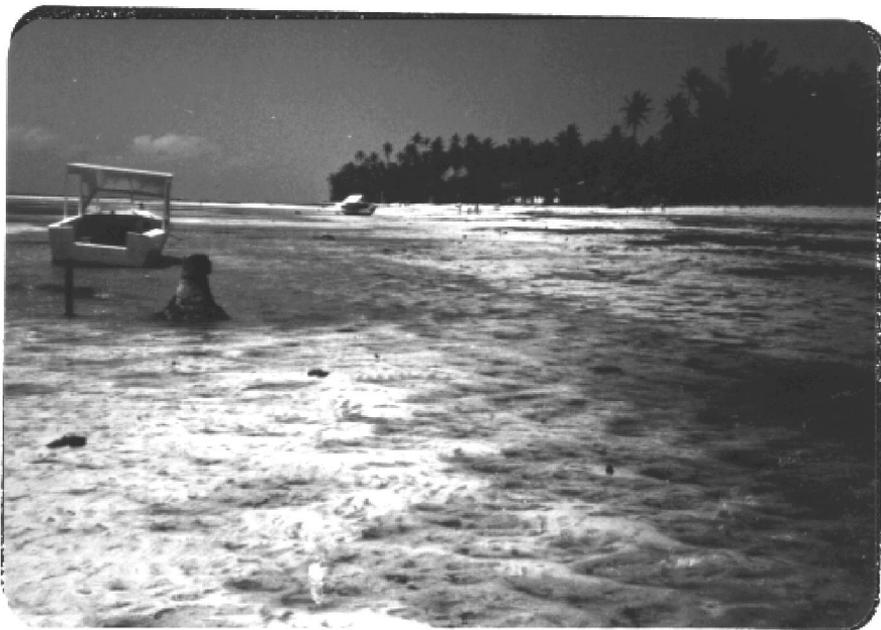
Plate .6 shows coastline retreat in front of Kanamai beach leaving a coconut stump (s) 50 m from the present coastline (September, 1990; Photo by P. Abuodha).

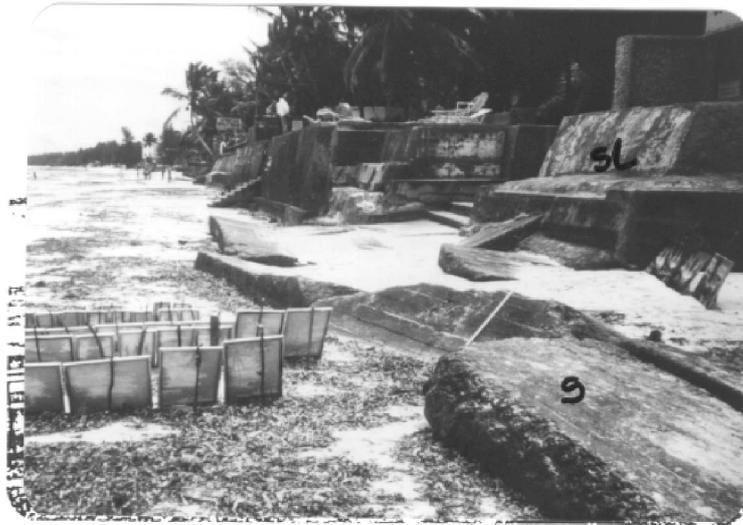
Plate 7 shows a thick seawall (s) at Bamburi. Note another seawall (s1) behind the failed seawall (September, 1990; Photo by P. Abuodha).

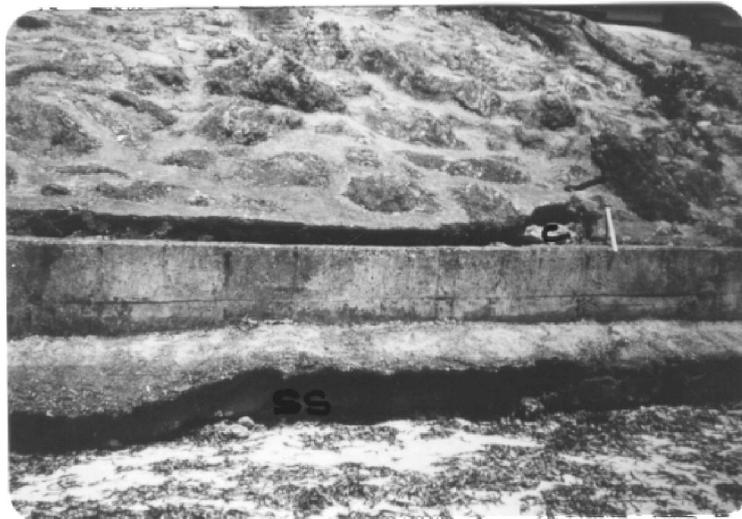
Plate 8 shows seawall along Nyali beach. Note crack (c) on the wall and sediment scour (ss) beneath the wall (September, 1990; Photo by P. Abuodha).

structures causes very drastic changes on the beach which include the increase of intensity of longshore currents, hastening removal of the beach. They also concentrate wave and current energy at the ends of the wall, increasing erosion at these points.
